TENTING CASE STUDY

Clinical study showcasing recommended clinical protocol for EthOss

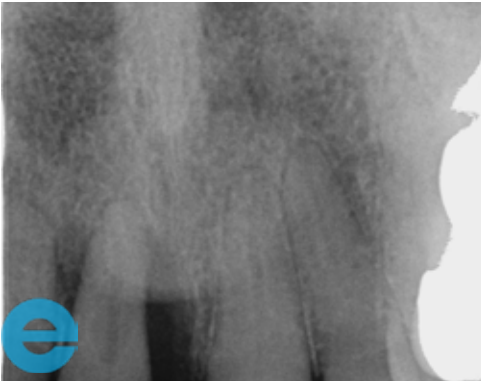
1. Initial situation. Periapical radiograph showing resorption

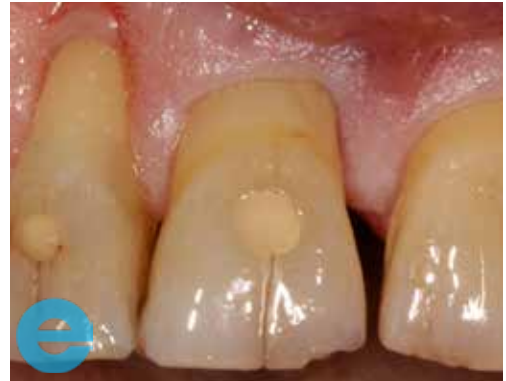
2. Initial presentation - thin buccal tissue on tooth

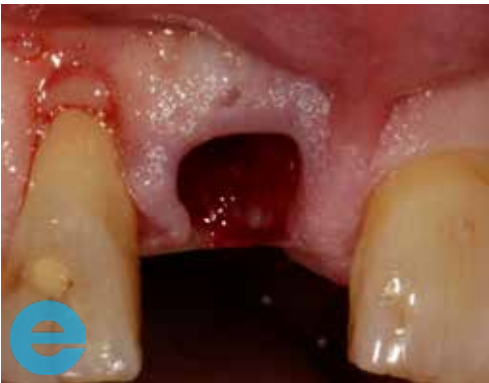
3. Atraumatic extraction leaving the socket epithelium intact

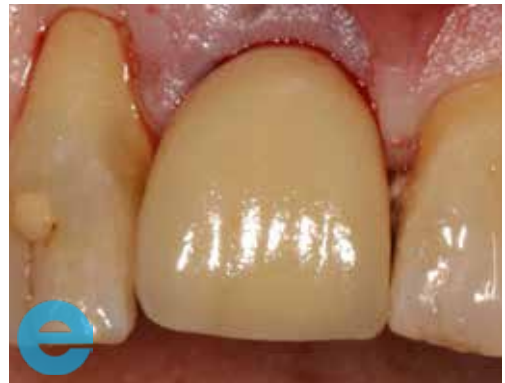
4. Maryland bridge, note close adaptation and support of the socket periphery.

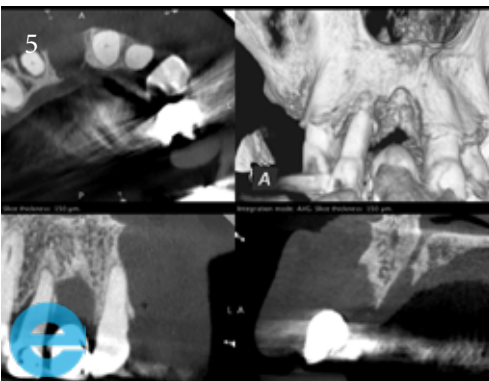
5. Two weeks following extraction - CBCT image of the extraction socket

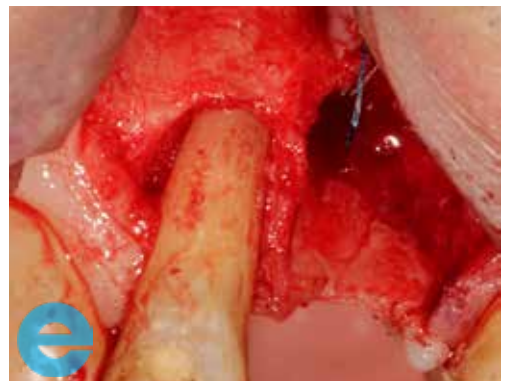
6. Four weeks following extraction - surgery, flap raised, completion of degranulation.

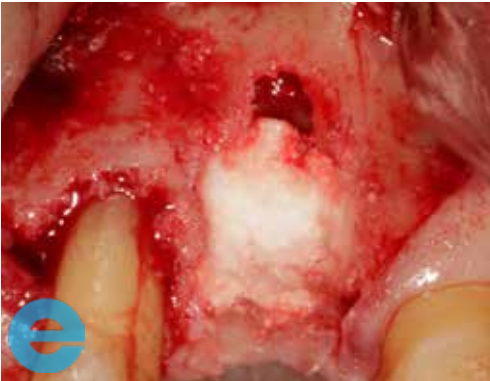
7. Palatal defect repair with EthOss®

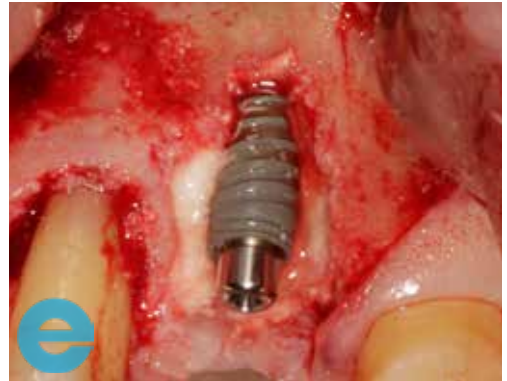
8. Implant placement with 2 mm cover screw

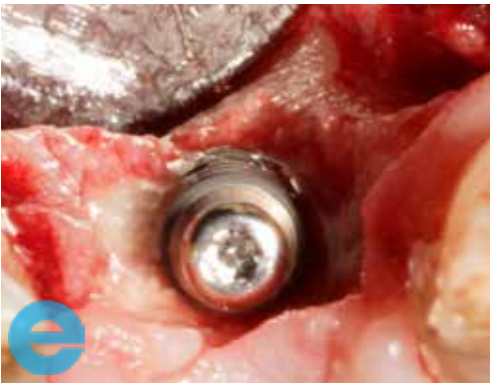
9. Implant placed in ideal position for cement-retained prosthesis.

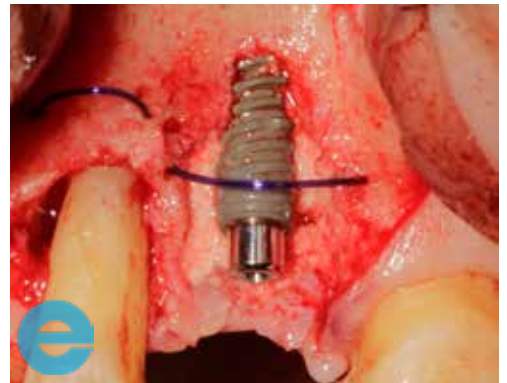
10. Placement of 2-0 PDS tenting sutures to create "dome device" to prevent micromovement of the graft material

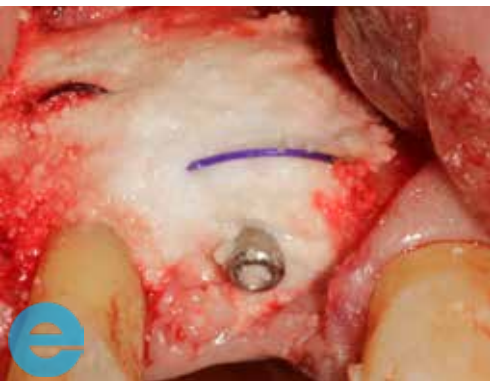
11. Placement of a "wetter" mixture of graft material in stages under the dome device, carefully drying and compressing with each stage.

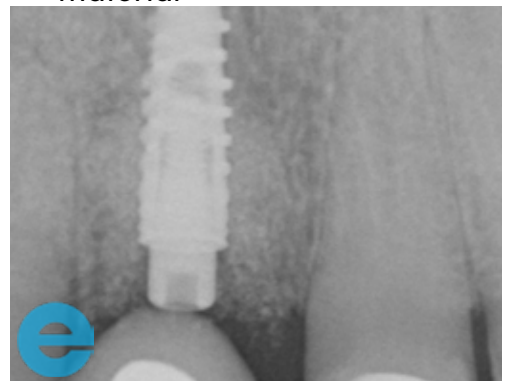
12. Control radiograph at twelve weeks healing.

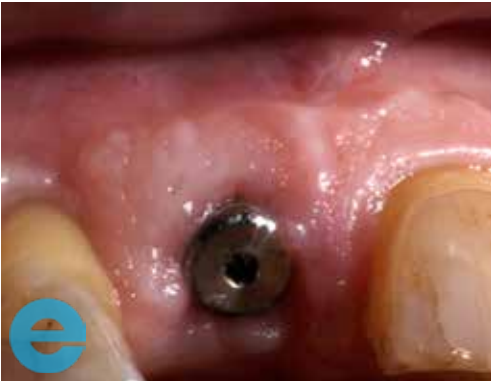
13. After two weeks healing post second stage.

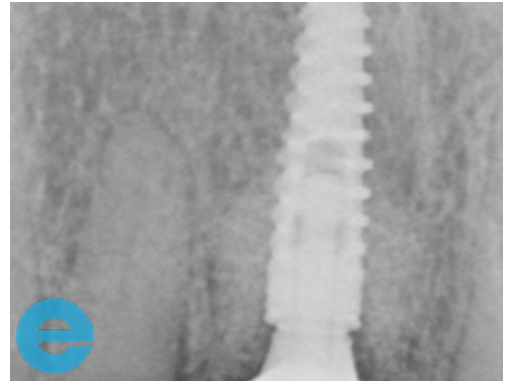
14. Twelve months control, following crown cementation

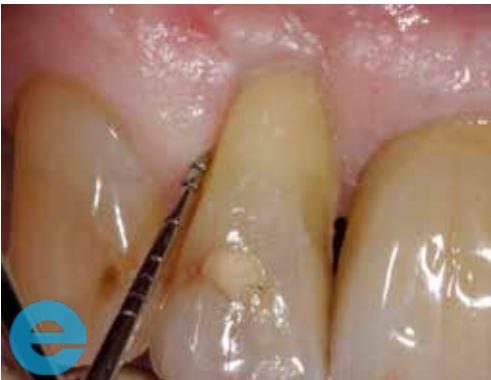
15. Probing the distal of tooth 12 shows 1 mm pocket depth indicating adequate healing response.

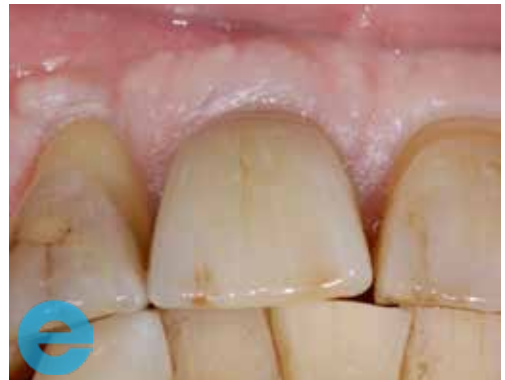
16. Final tissue maturation at twelve months, shows stippling, contour and volume consistent with underlying bone health.

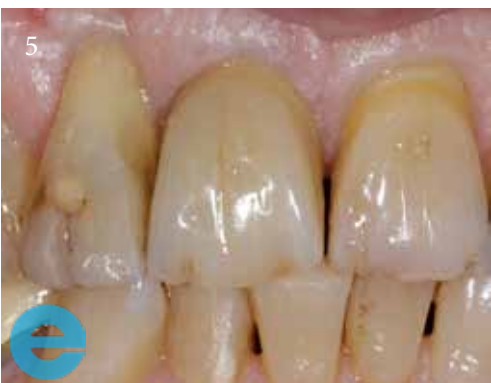
17. Final tissue maturation at twelve months, shows stippling, contour and volume consistent with underlying bone health
