PATIENT MEDICAL HISTORY

Patient suffered from localised periodontitis affecting all lower incisors with severe bone loss

Case from Dr Jonathan Cochrane, Bristol, UK

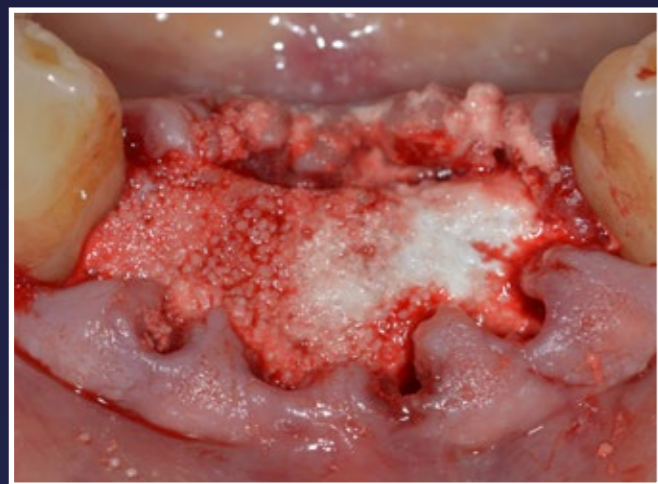
3. Intraoperative situation after the application and setting of EthOss in situ

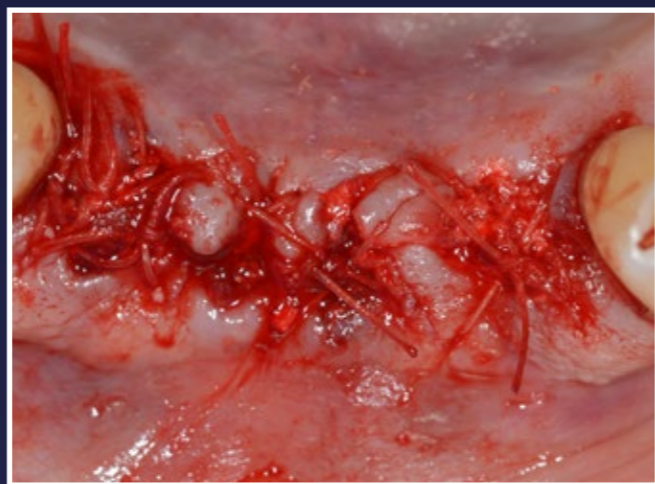
4. Surgical wound sutured with Vicryl Rapide - primary closure almost achieved

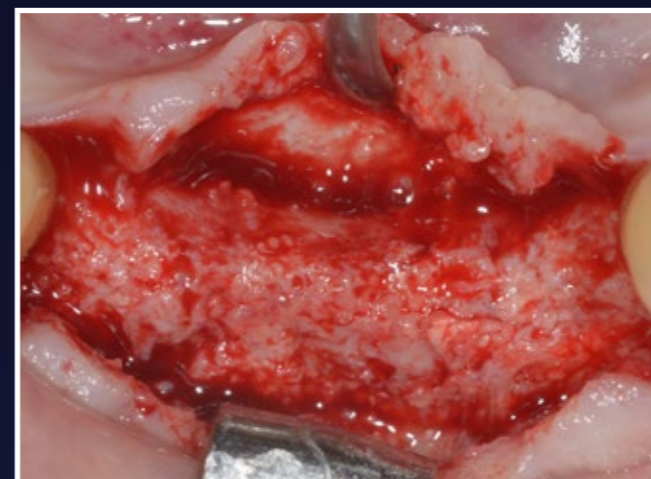
5. Re-entry 10 weeks later, single crestal incision made

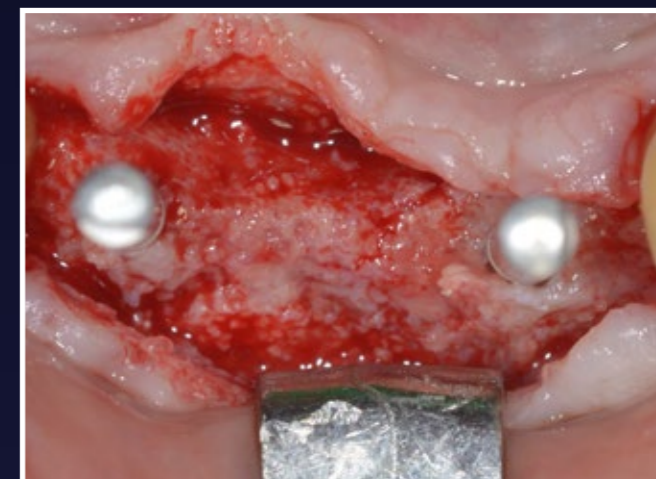
6. Freehand placements with the initial twist drills in the lateral positions - occlusal view

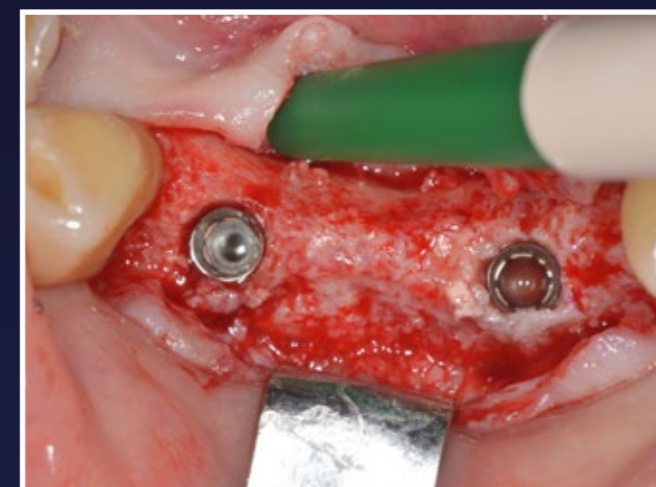
8. Immediately after placing the implants in the optimal three dimensional position - occlusal view

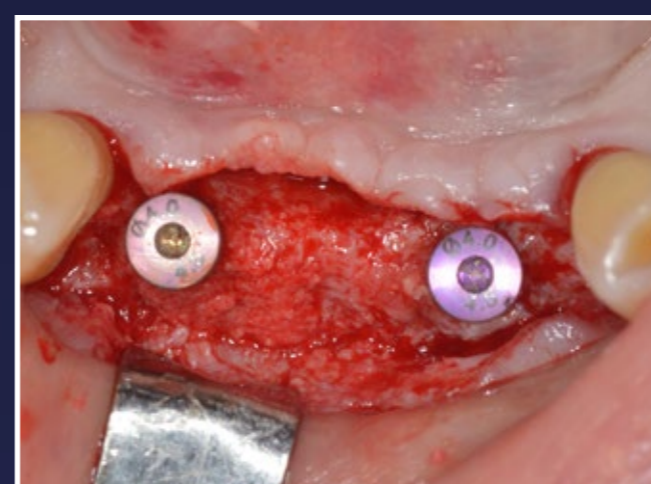
9. Healing abutments placed - occlusal view

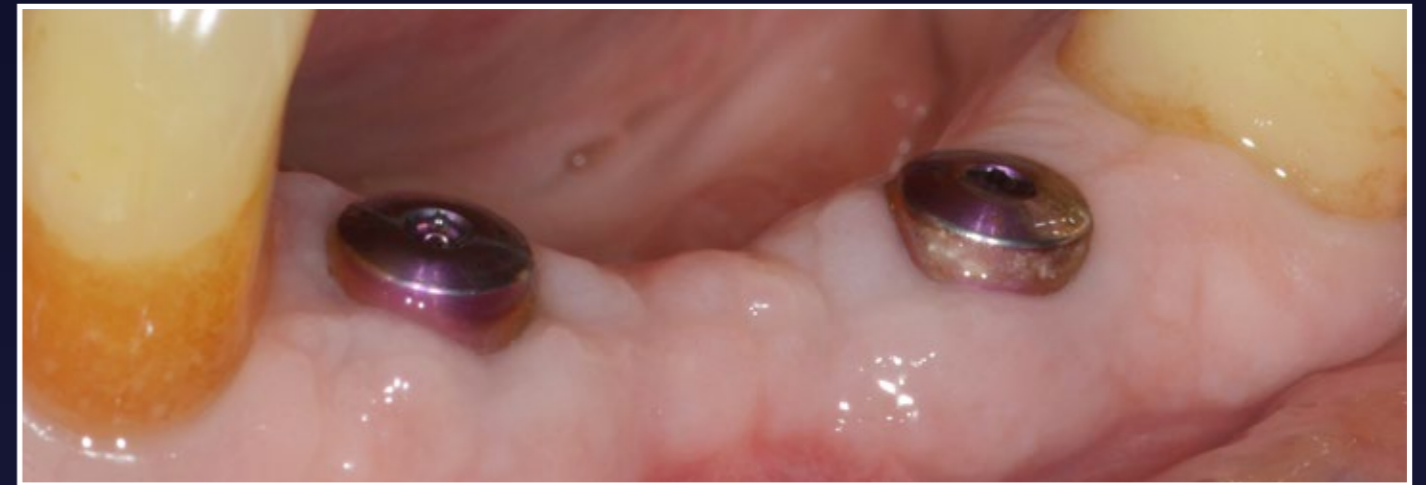
14. Restoration phase, 10 weeks later, showing nicely healed, regenerated keratinised soft tissues

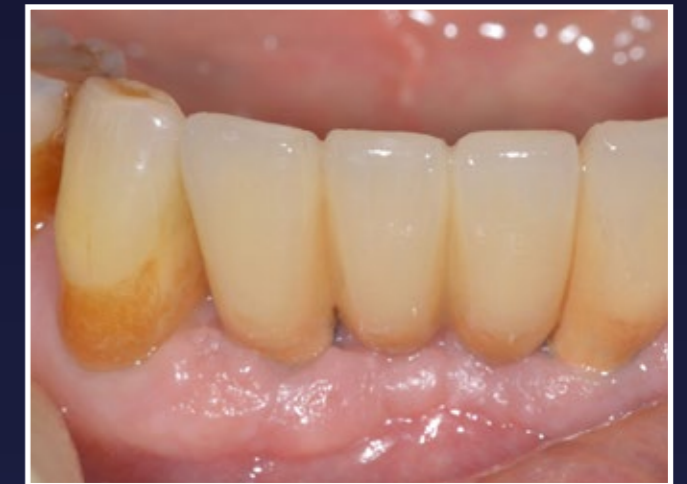
16. Final implant bridge immediately after fitting - buccal view
