PATIENT MEDICAL HISTORY

Failed root canal therapy UR1

Endodontic retreatment carried out twice by specialist endodontist to no avail

Dr Mark Worthing,  
Hereford, UK

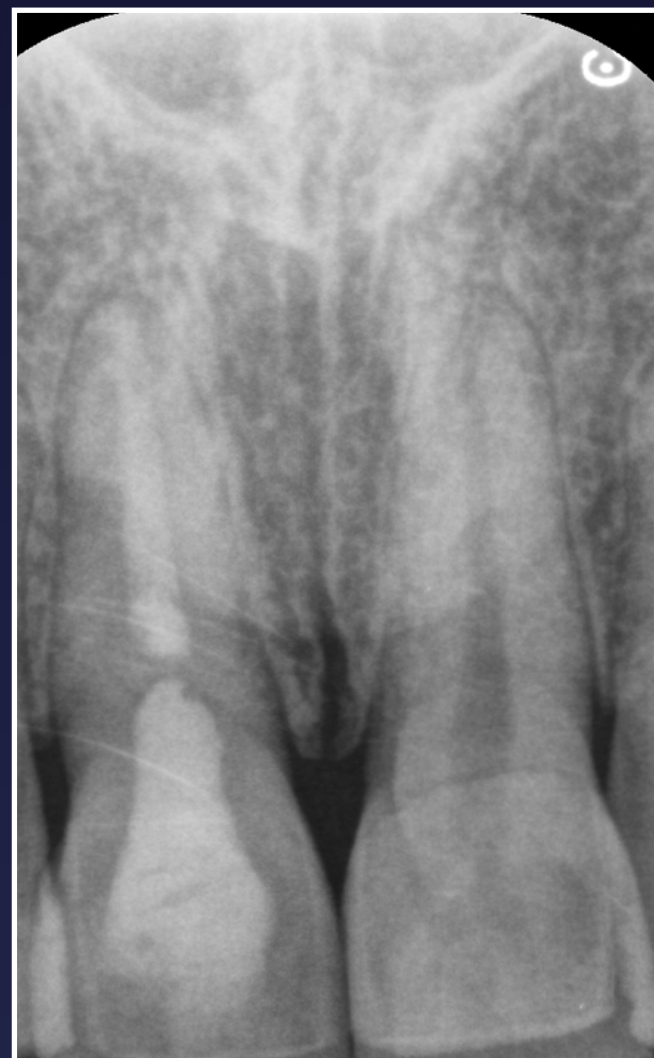
1. Pre-op

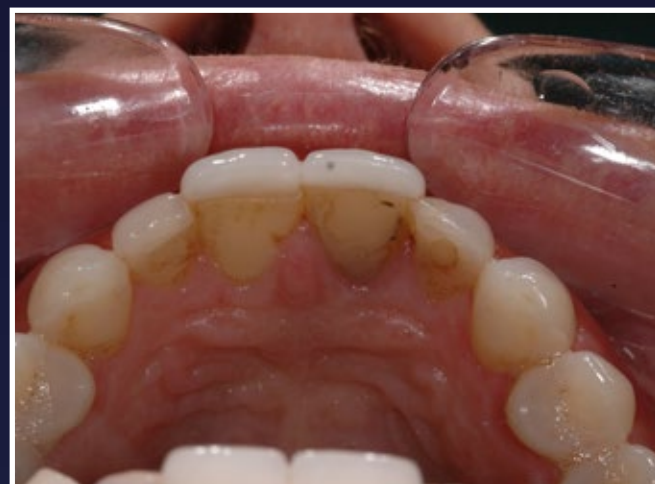
2. Pre-op occlusal view

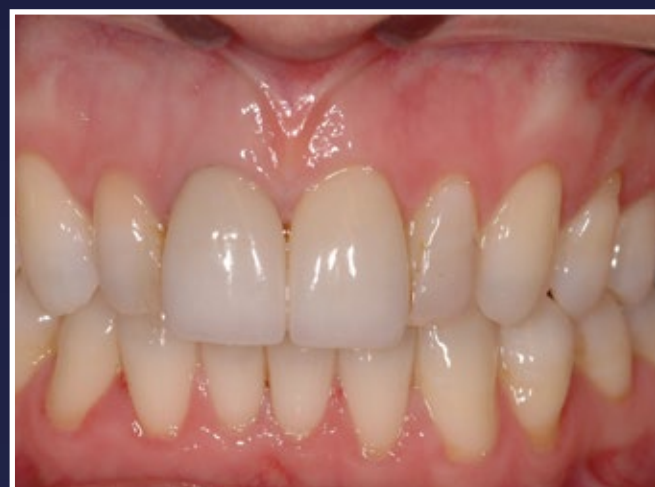
3. Pre-op

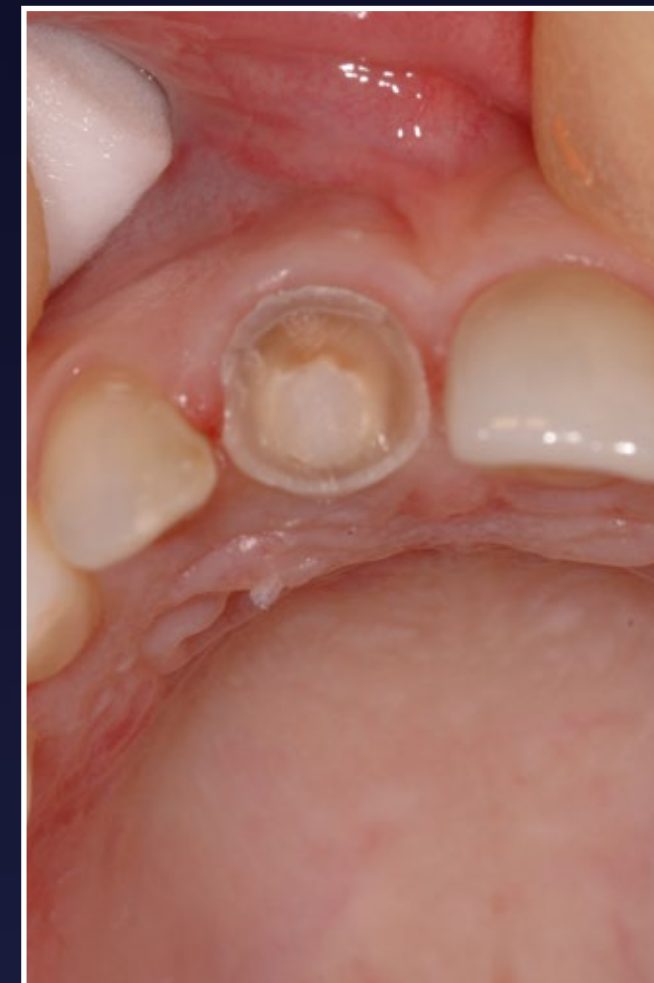
4. Decoronation

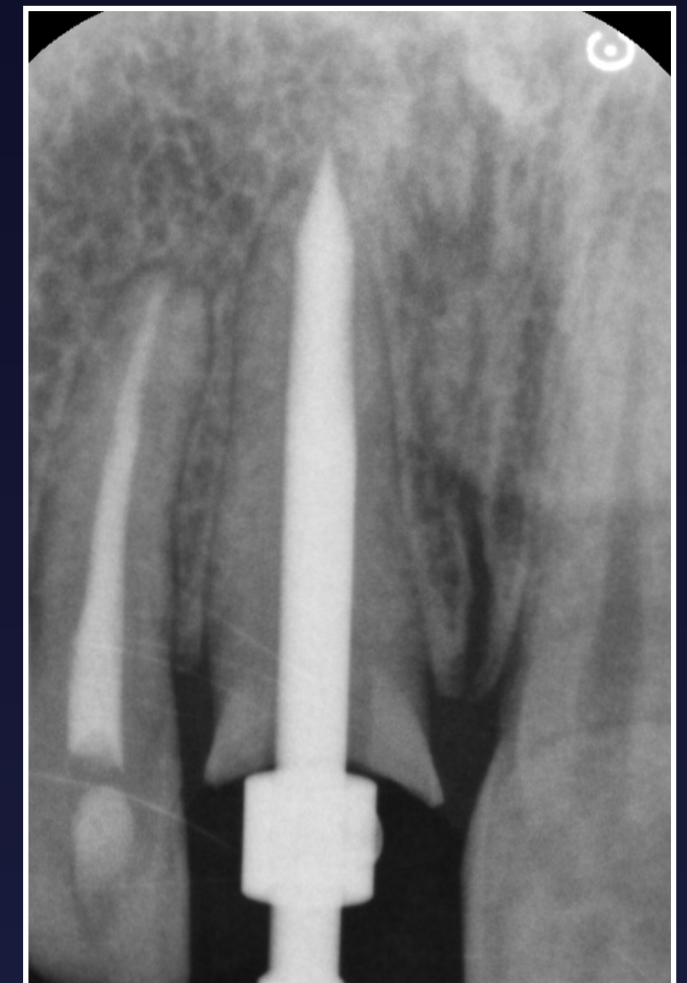
5. Check radiograph for partial extraction therapy

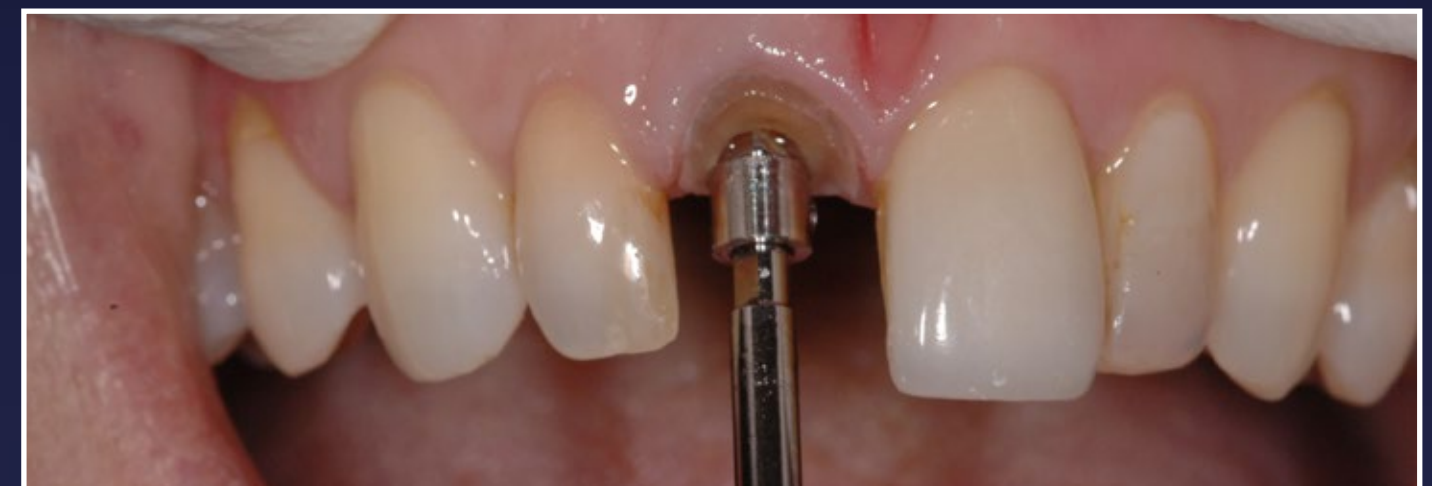
6. Partial extraction therapy preparation

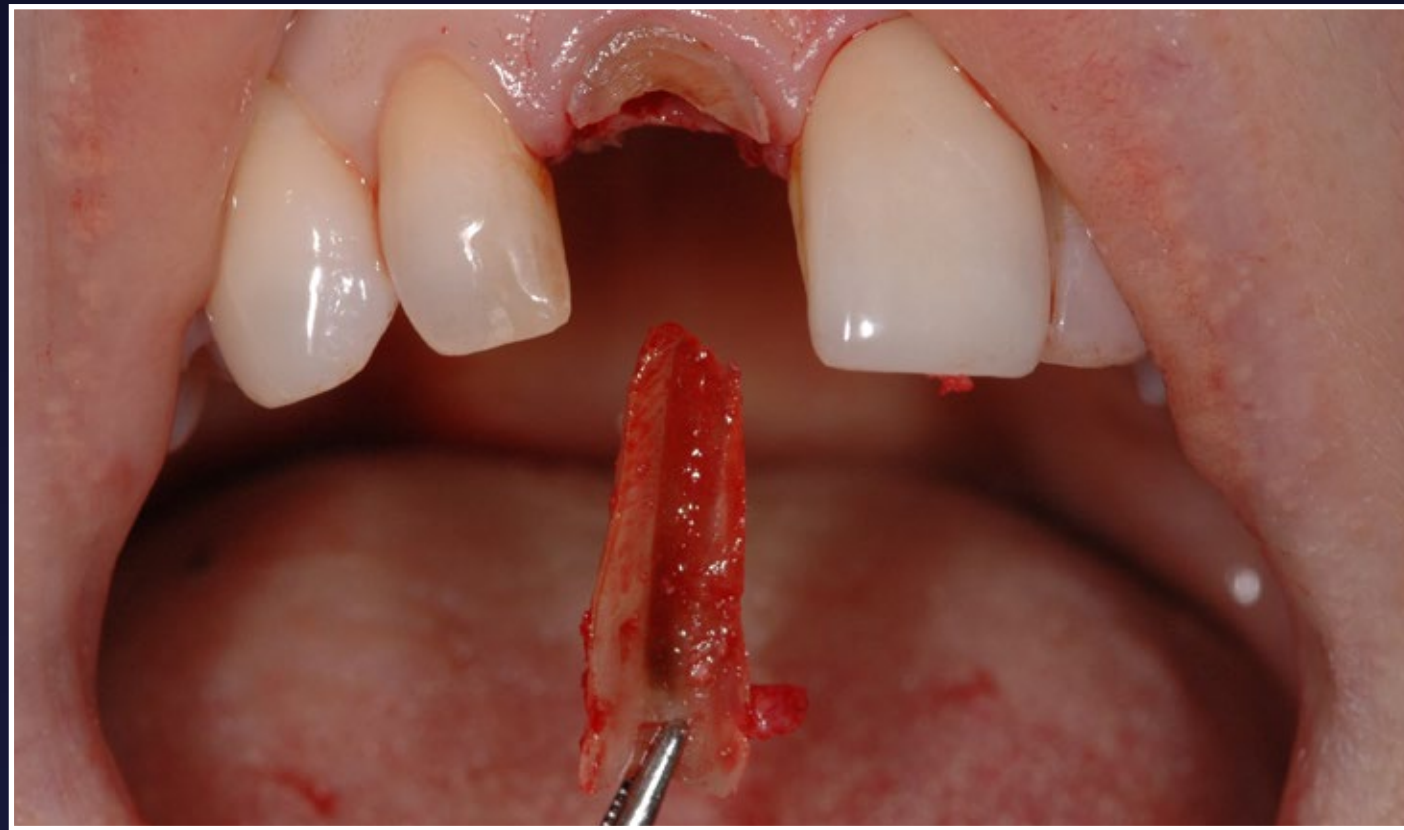
7. Partial extraction therapy

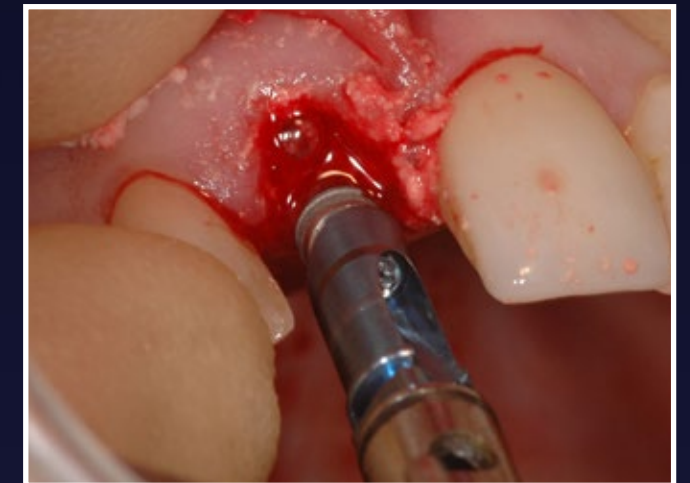
10. Fixture placement INVERTA by Southern Implants

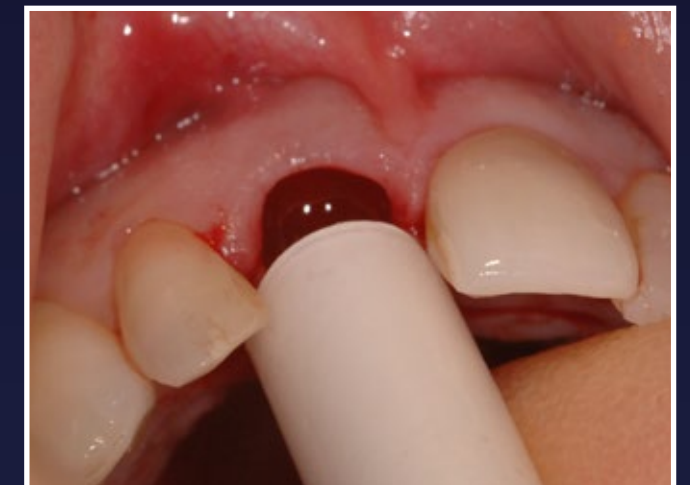
12. EthOss in jump gap

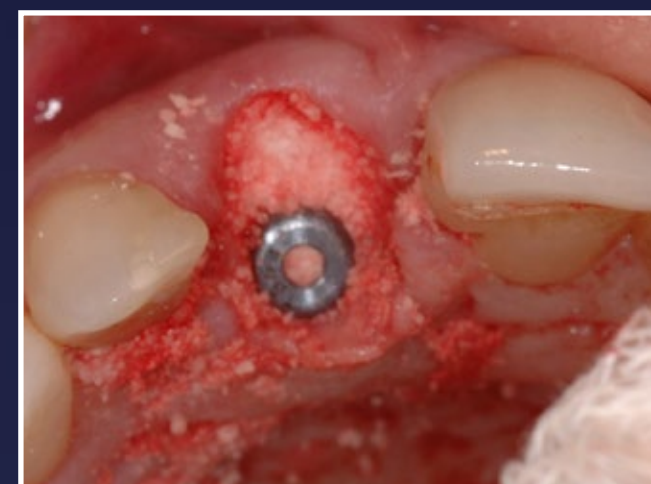
13. EthOss is placed

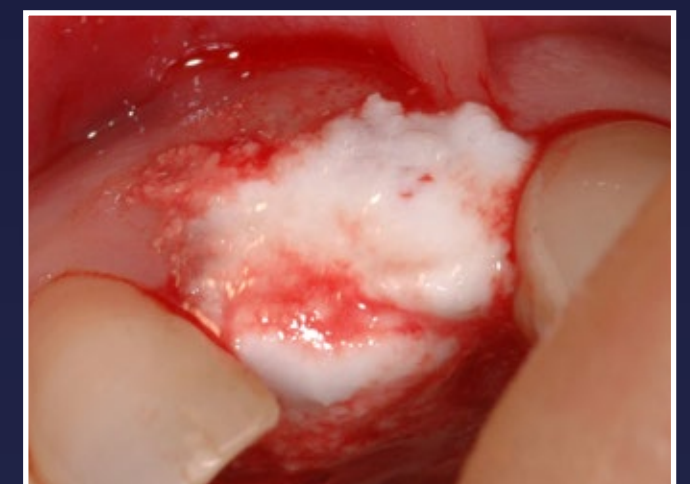
14. Additional EthOss is placed

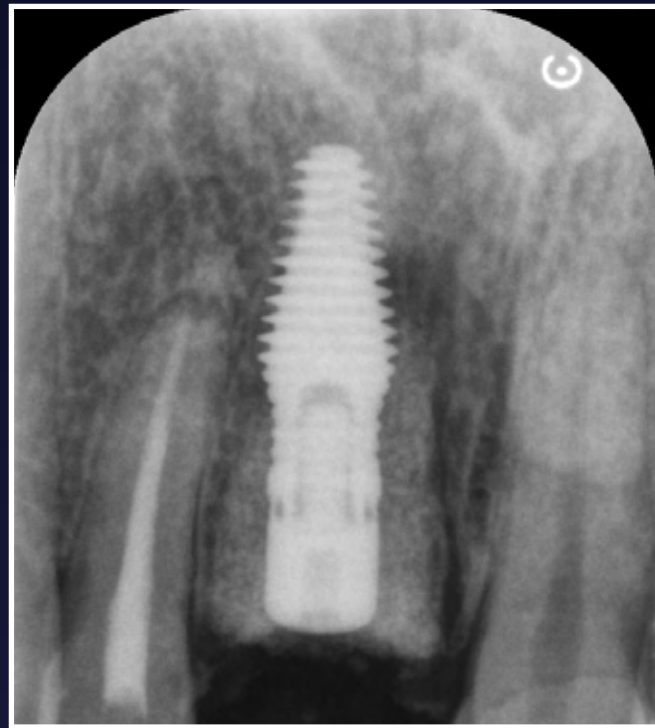
15. Fixture placement INVERTA by Southern Implants

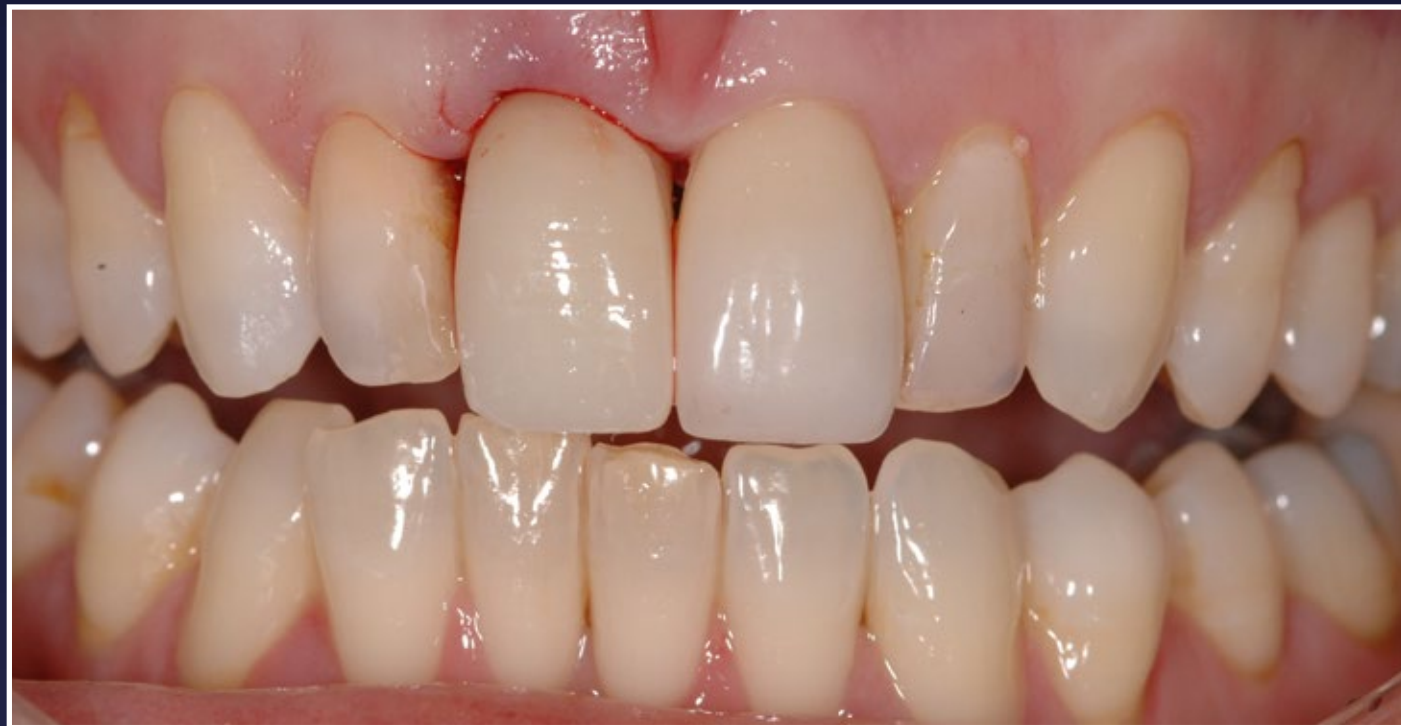
17. Immediate restoration

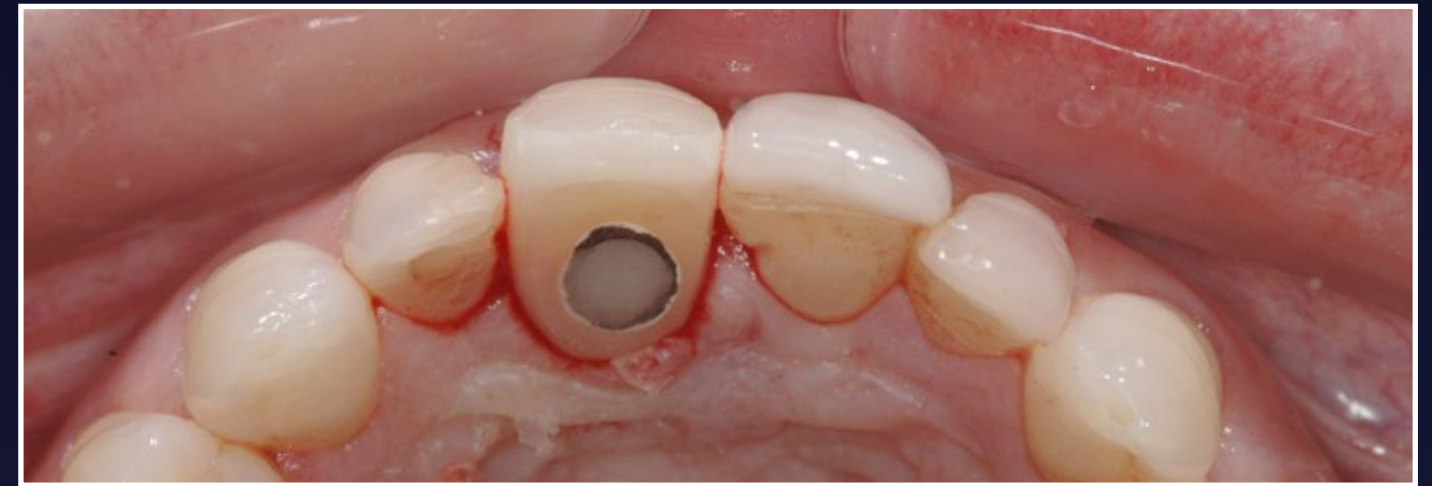
18. Immediate restoration

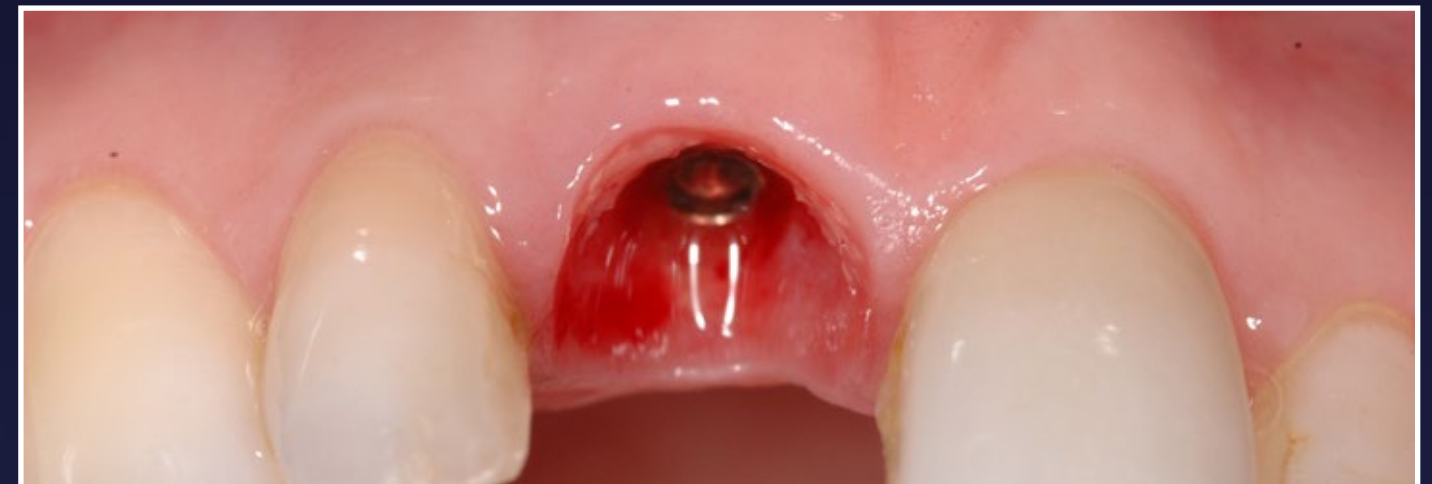
19. Immediate restoration

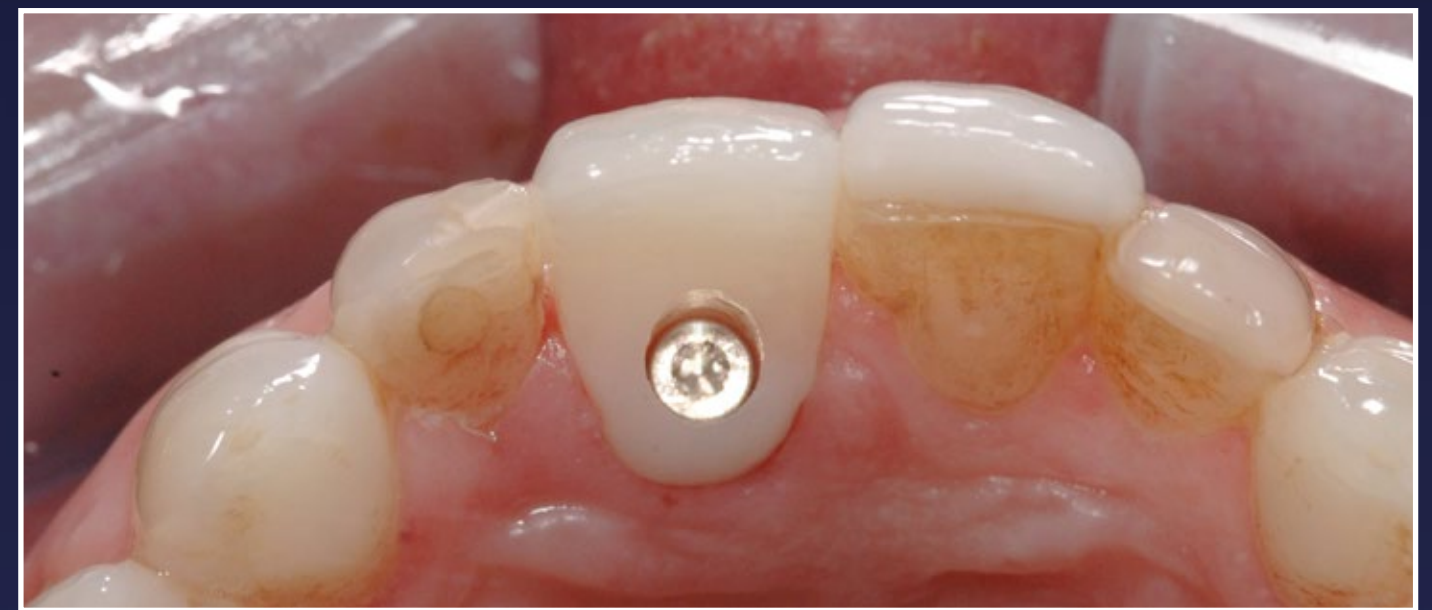
20. Final crown

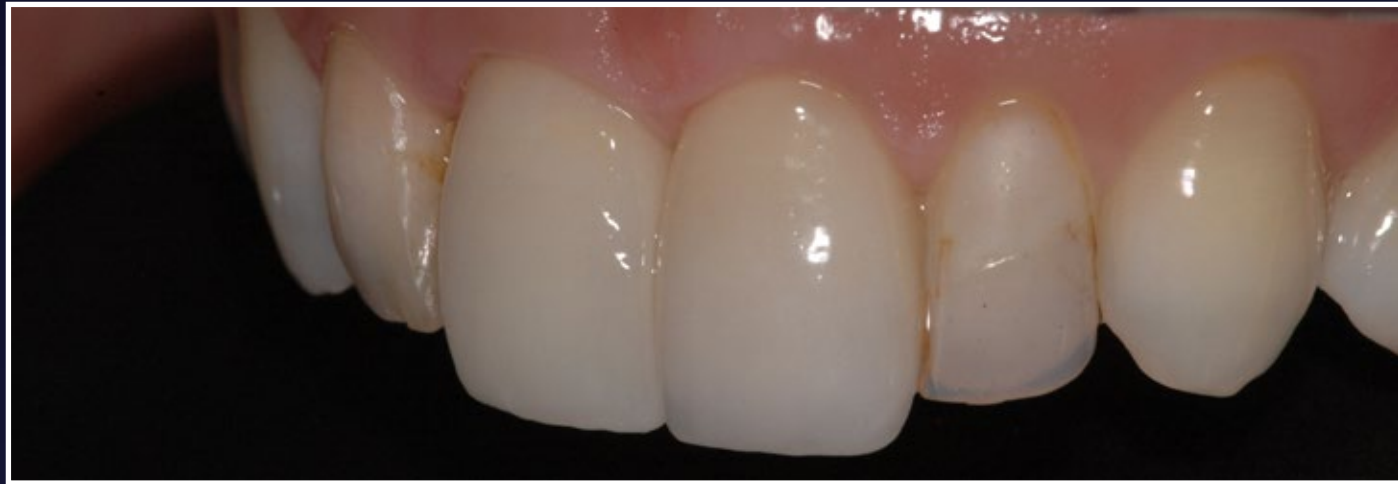
21. Final crown
