Case referred from endodontist
LR7 had a poor prognosis due to fracture in MB root

Case from Dr Peter Fairbairn,
London, UK

“Push-in” Implant Technique

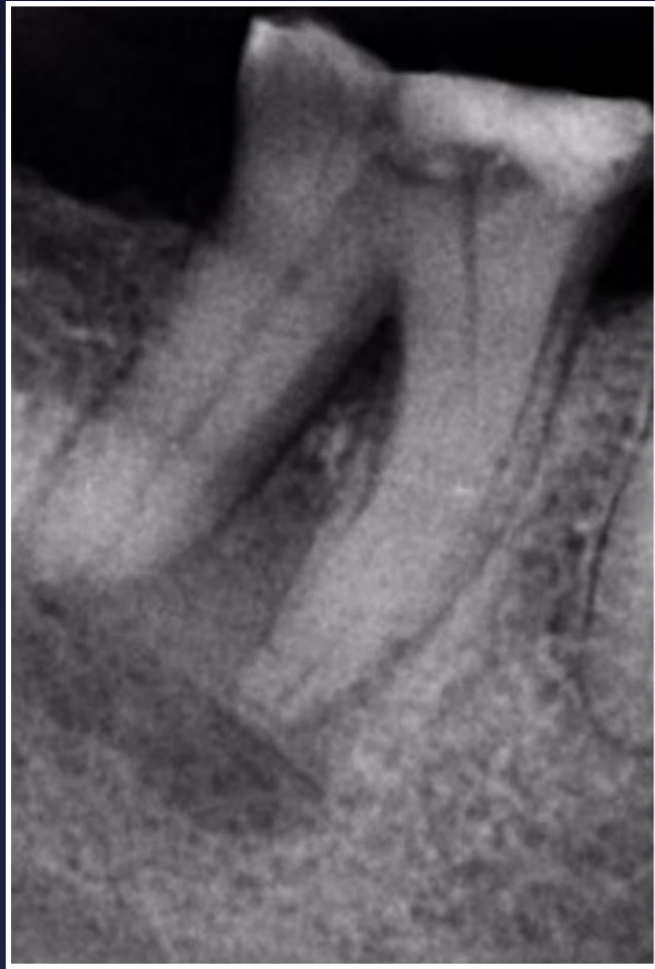
1. Referred to Endodontist but was advised of poor prognosis due to fracture in MB root

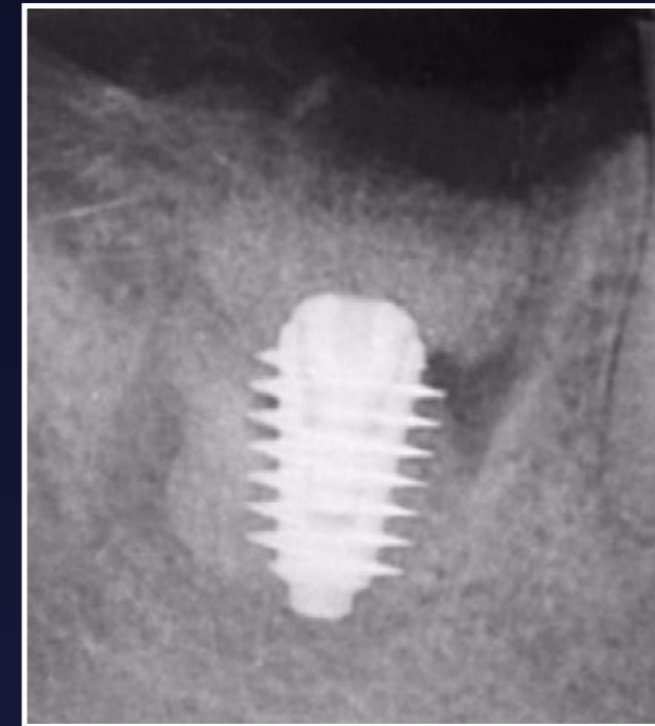
8. Radiograph at placement

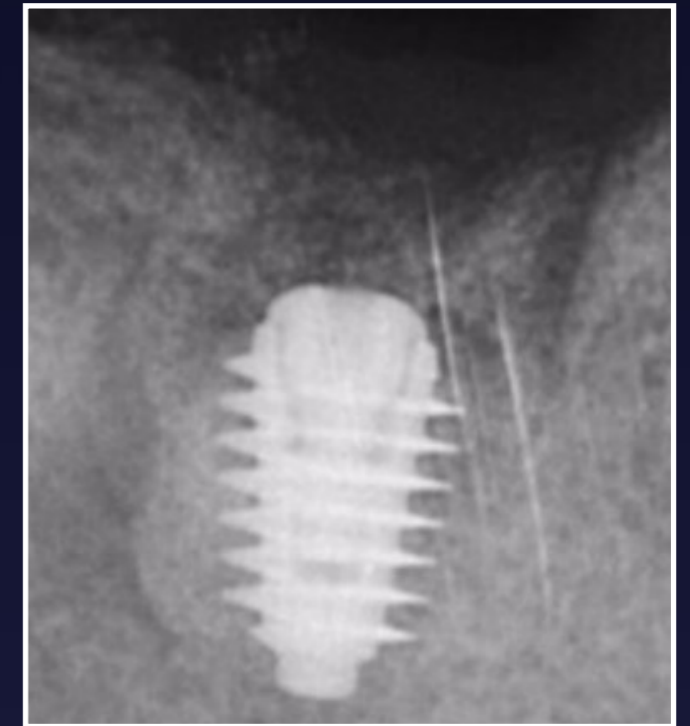
9. Radiograph 1 week post-op, great result

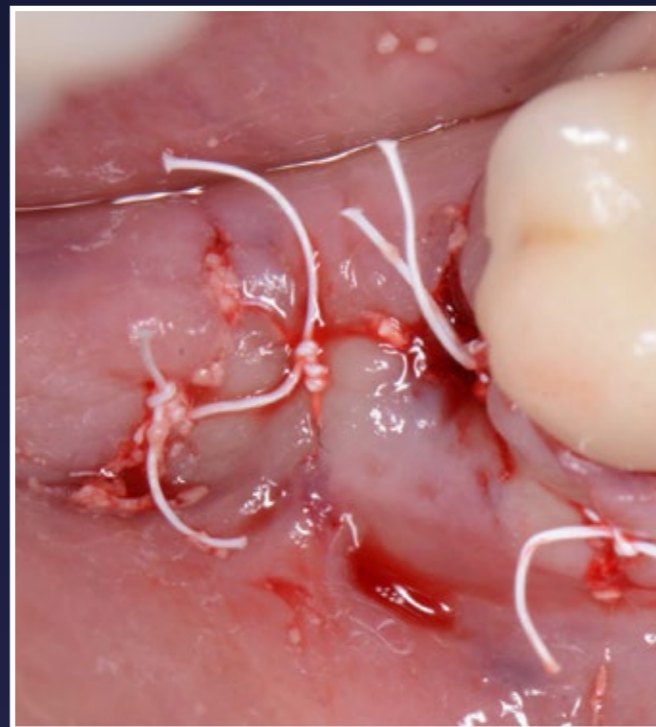
7. Sutured closed PFTE 3.0

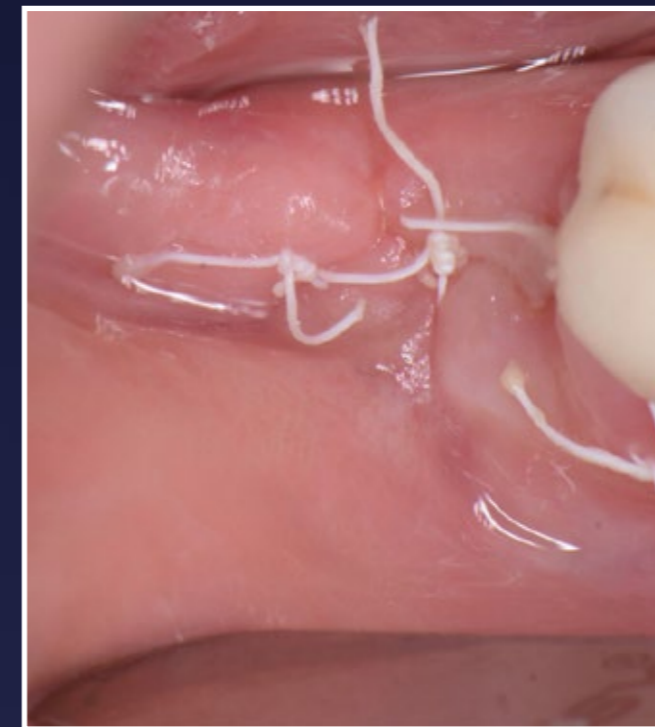
10. 1 week post-op, sutures to be removed

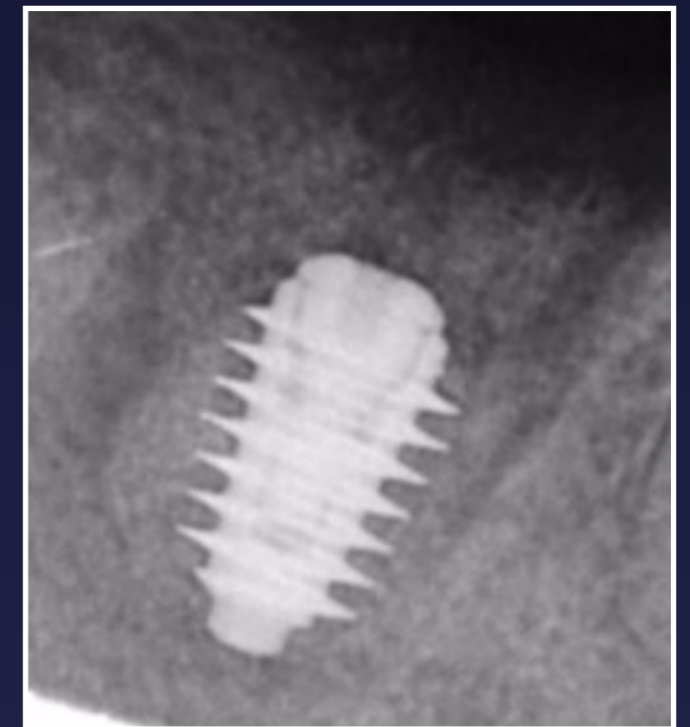
12. 10 weeks later implant is ready to load

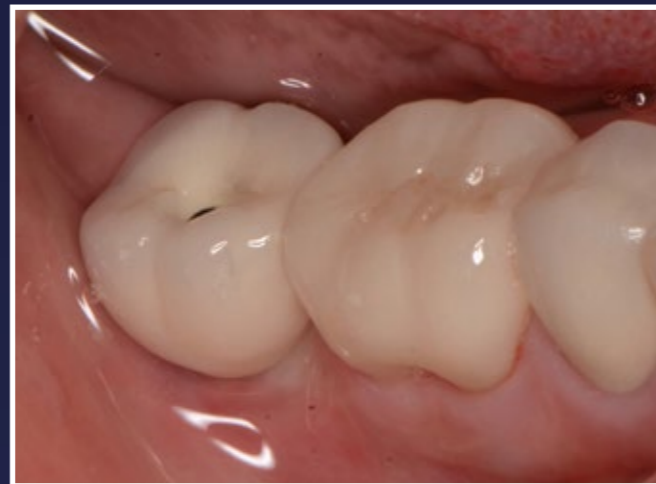
17. Screw retained and max crown on the LR7
