PATIENT MEDICAL HISTORY

Case from Dr Ragnar Ilp,
Estonia

Upper First Molar Socket Graft

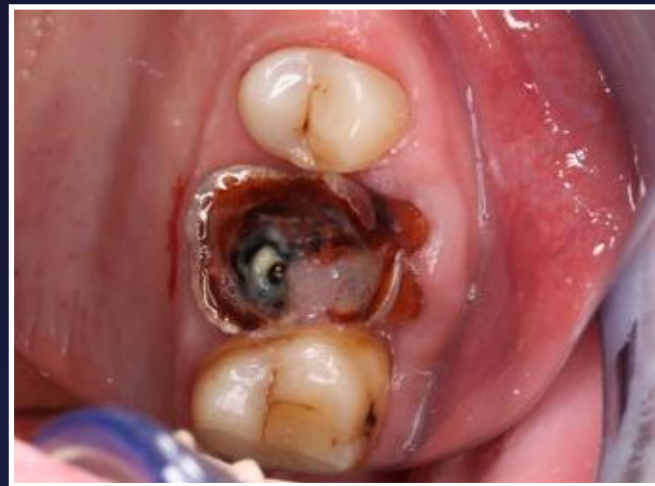
1. Upper first molar (UR6). Hopeless diagnosis

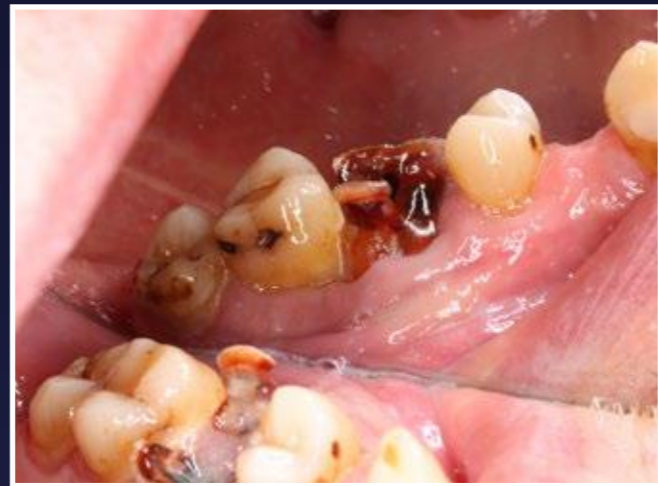
2. Distal root is very close to the 2nd molar

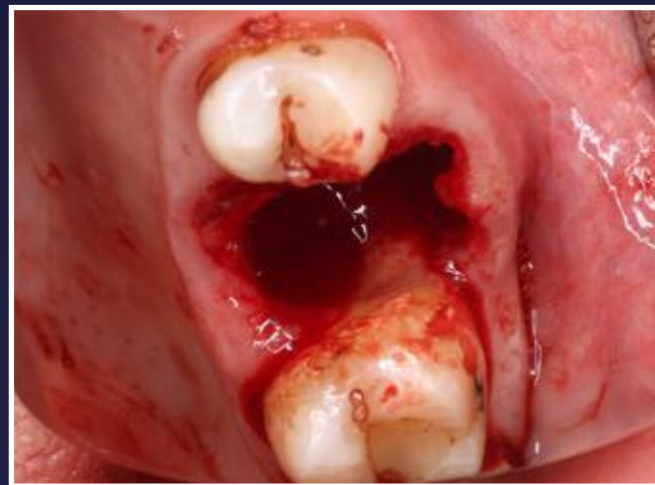
3. MB root of 2nd molar has bone loss due to the proximity of the hopeless tooth. The buccal plate was also missing almost to the apices

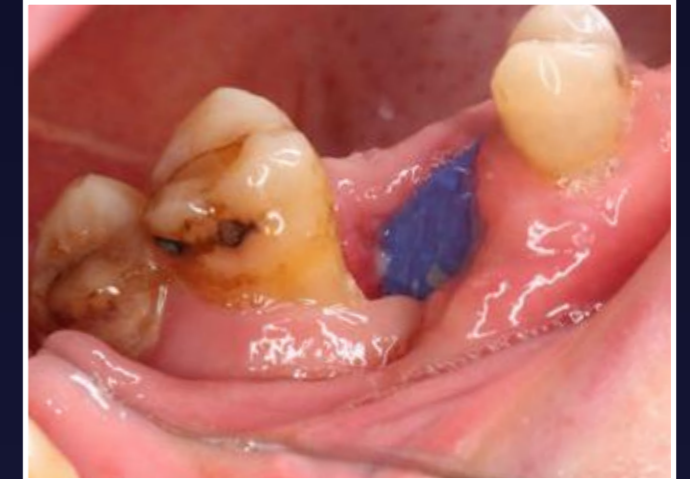
6. 2 weeks later difficulties caused by lack of stability of both materials. After two additional weeks the membrane came off by itself

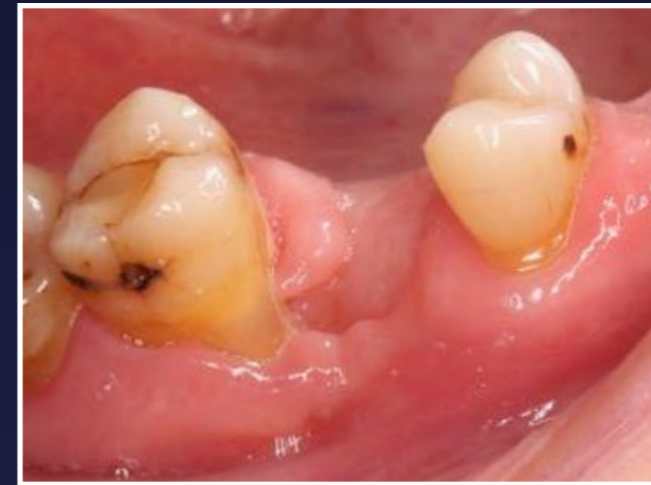
7. 5 months later, appointment time for implant surgery

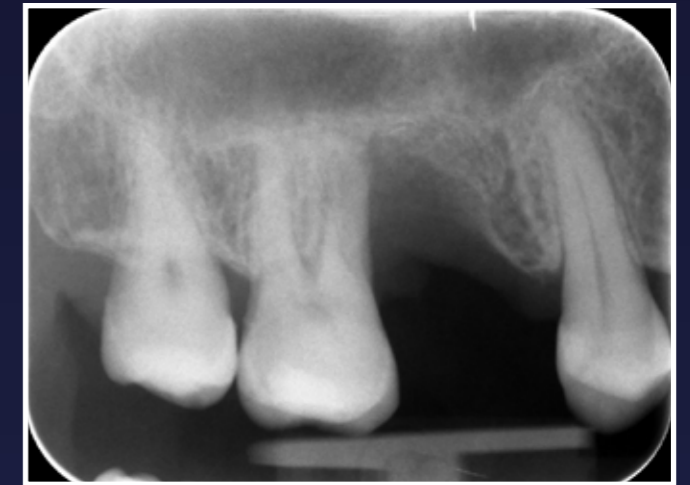
8. Radiograph prior to surgery

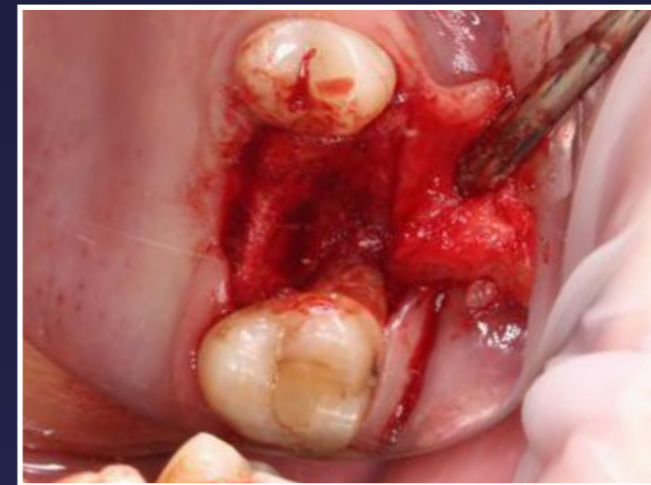
9. Degranulated site, bone loss almost to the apex of the 2nd molar

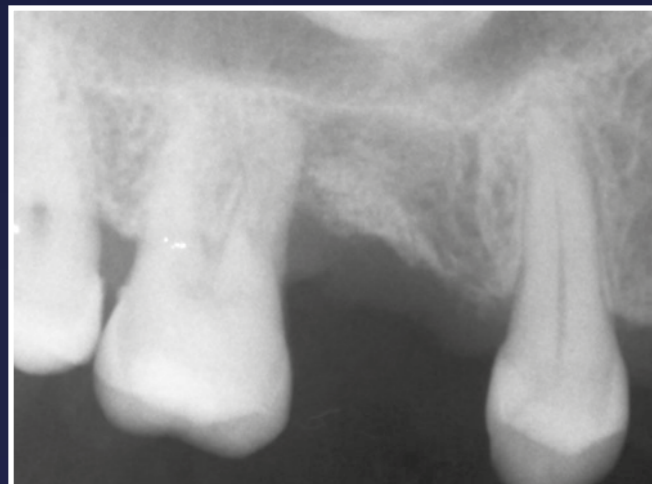
15. Radiograph showing new host bone

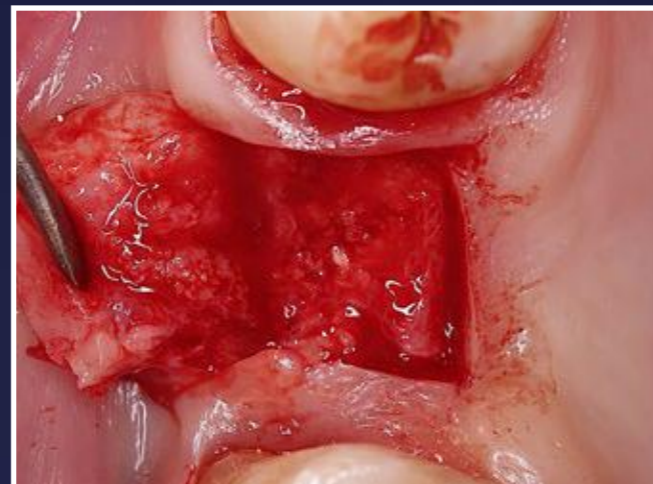
16. New host bone visible

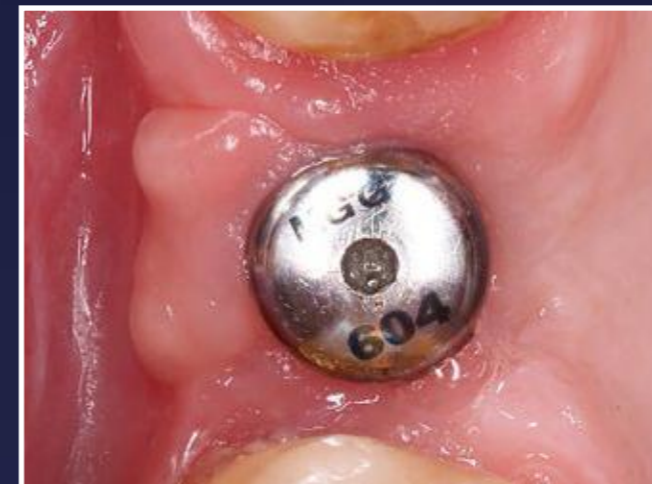
21. Tissue maturation before removing healing cap

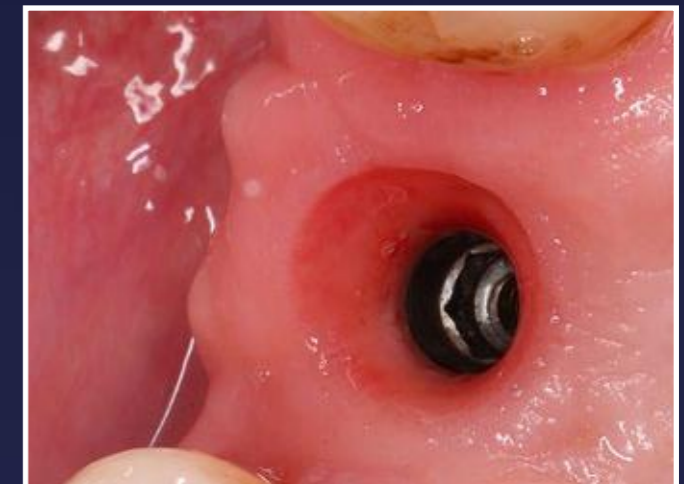
22. 3-4 mm of tissue height, as required. Everything is stable and feels solid

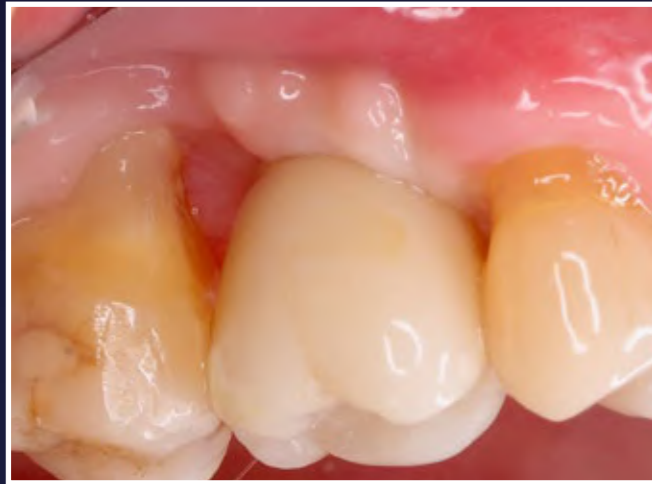
25. Distal part is cleanable, still 4mm probing depth for UR7
