UPPER RIGHT PREMOLAR

The following scans were taken at 9 months post op

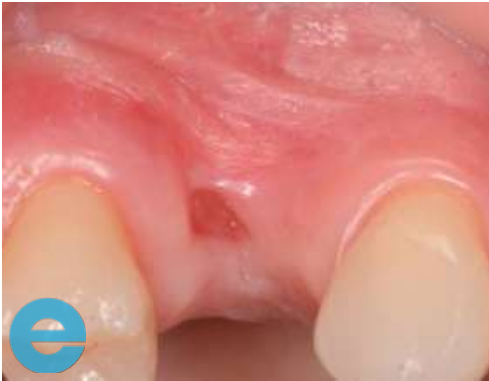
1. Vertical and horizontal loss, hard and soft tissues

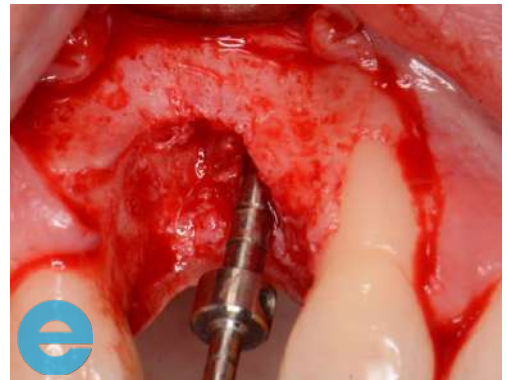
4. Hard tissue loss on the palatal aspect - check the angle

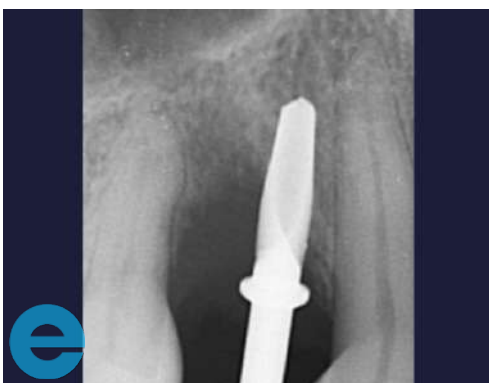
5. Radiograph showing hard tissue loss on the palatal aspect - check the angle

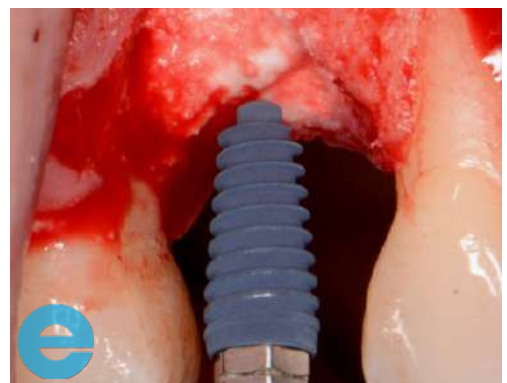
6. Palatal graft into the site and placement of 3.5 mm wide AnyRidge to the correct level (mm sub crestal)

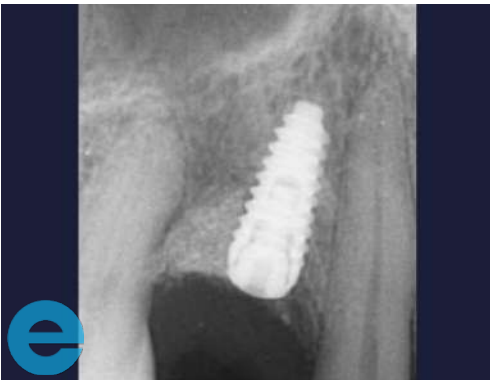
9. Radiograph of implant placement

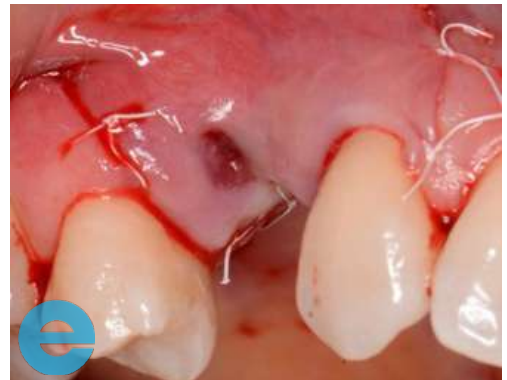
10. Passive closure using PTFE sutures. Small opening on palatal aspect

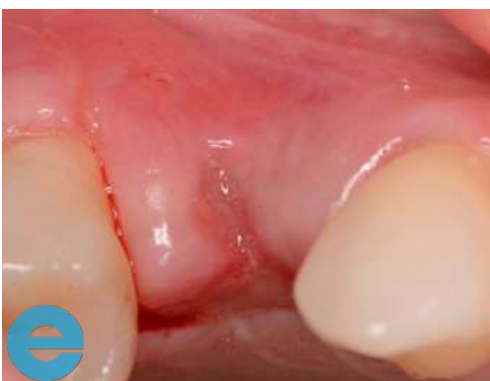
11. Sutures removed at 4 days - healing on the open palatal area by secondary intention

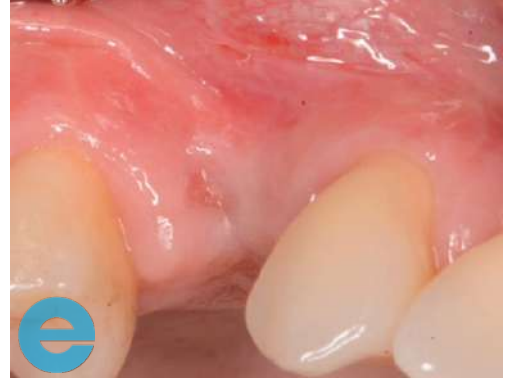
12. Healed site at 10 weeks

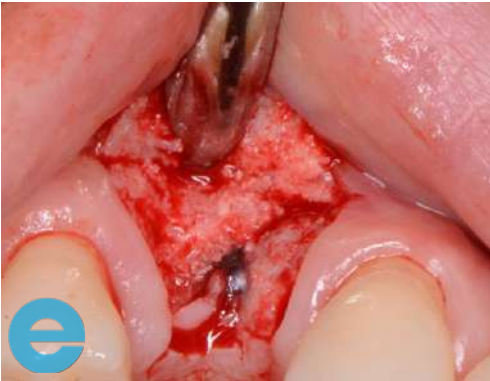
13. Small additional graft with EthOss

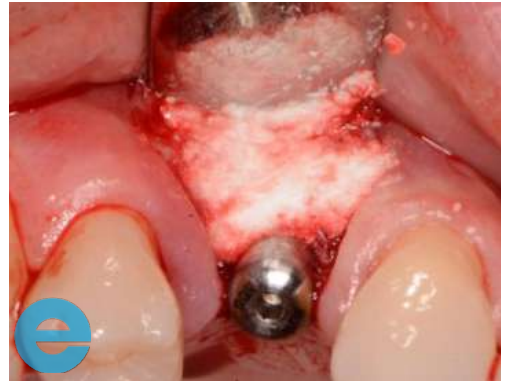
14. Healing cap placed

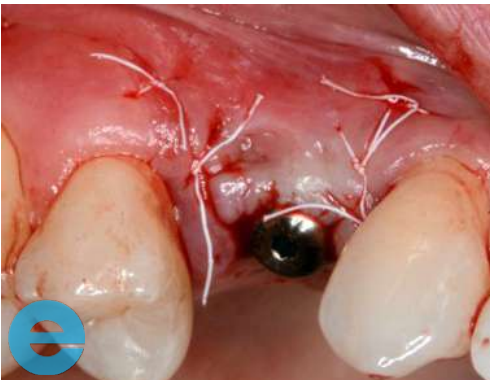
15. Sutures removed again at 4 days

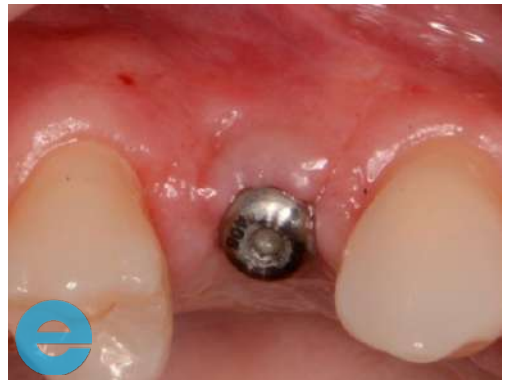
16. Bigger healing cap to improve emergence and Blue®M gel used for soft tissue healing

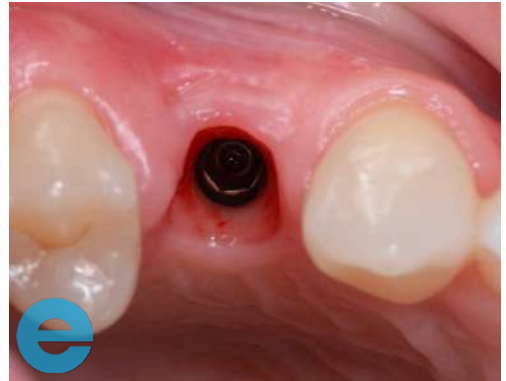
20. Loaded at 14 weeks post surgery, restored papillae
