TWO WALL PERIODONTAL TREATMENT

Female, 40 years old
Non-surgical treatment worked to reduce the inflammation but at this site the deep intrabony defect prevented the re-establishment of a normal sulcus
8mm probing pocket depth on tooth 42(d)
Case from Dr Renukanth Raman, Malaysia

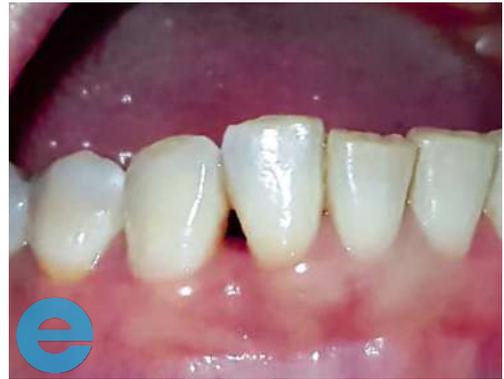
1. Initial situation

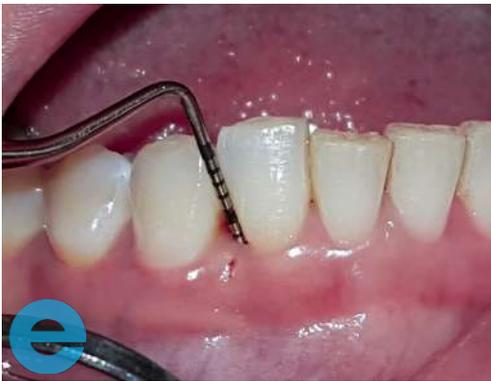
2. Pocket depth 8mm

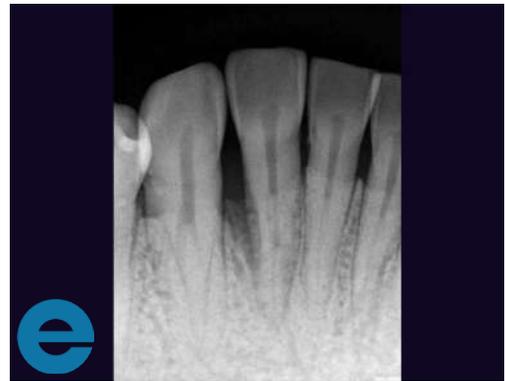
3. Pre-op scan shows what appears to be two-wall defect

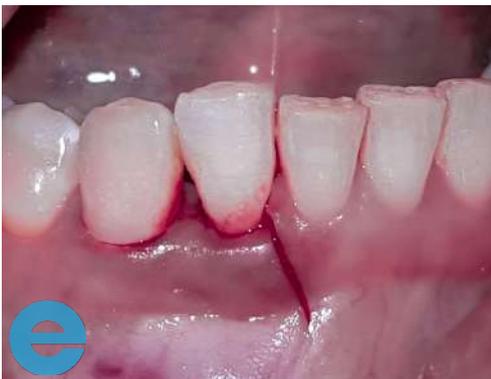
4. Less invasive papilla-preserving flap is raised as no collagen membrane is required

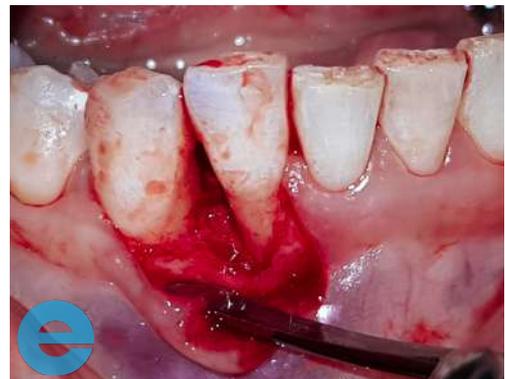
5. Defect visible

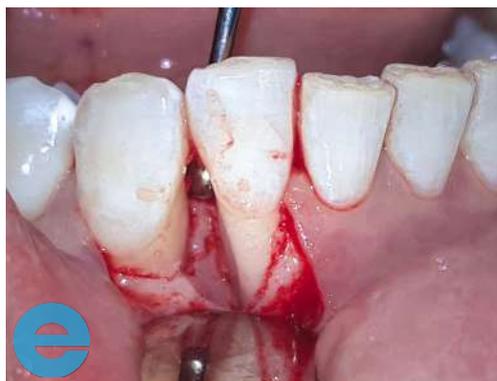
6. Osseous and root surface debridement reveals deep two-walled intrabony defect

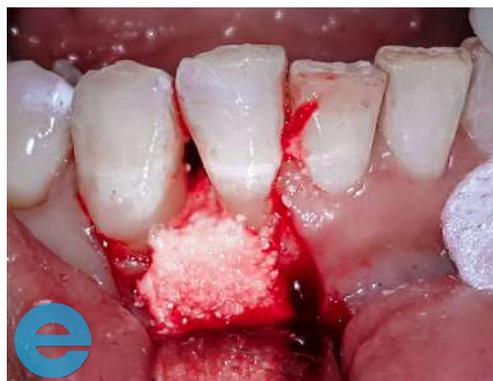
7. EthOss® bone grafting material placed and shaped/ moulded

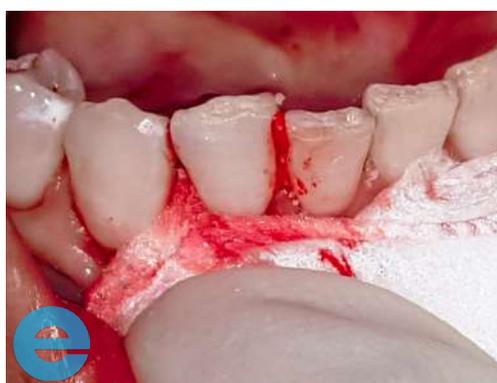
8. EthOss bone grafting material dried with sterile gauze for 5-6 minutes

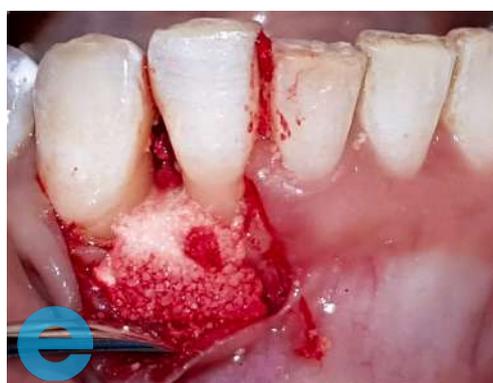
9. EthOss bone grafting material sets

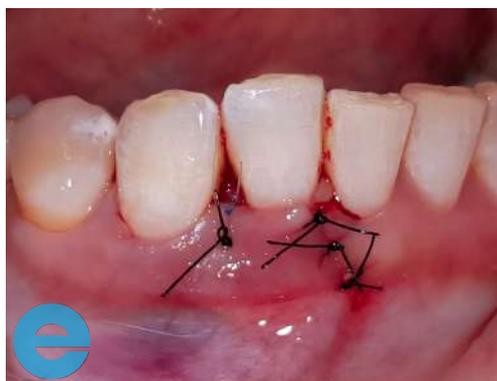
10. Suturing, passive primary closure

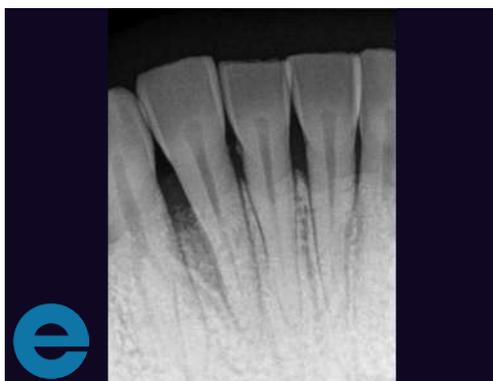
11. Radiograph immediately

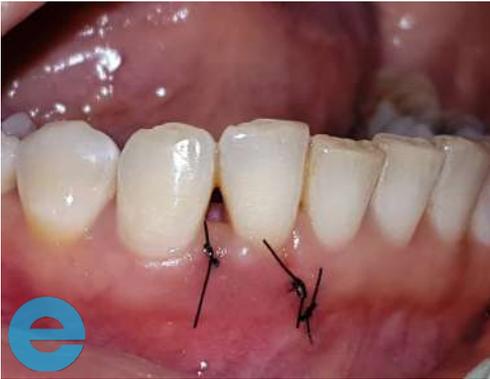
12. 1 week post op

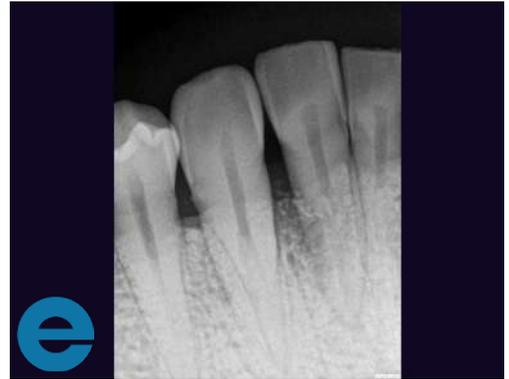
13. Radiograph at 2 months, slight radiopaque view of grafted area, this is to be expected as the Calcium Sulphate resorbs

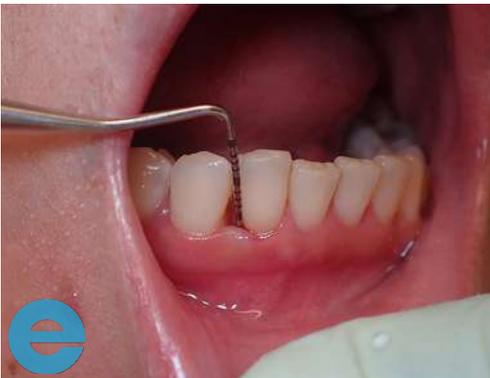
14. 1 year post op, 3mm probing pocket depth, good soft tissue healing

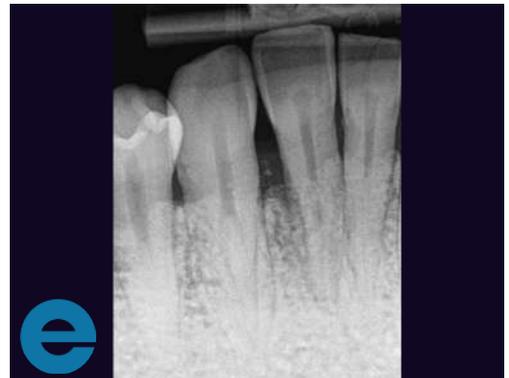
15. Radiograph at 1 year
