LOWER LEFT FIRST MOLAR CASE STUDY

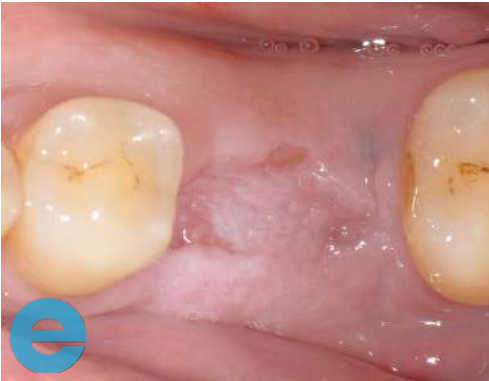
1. Clinical view four weeks after extraction.

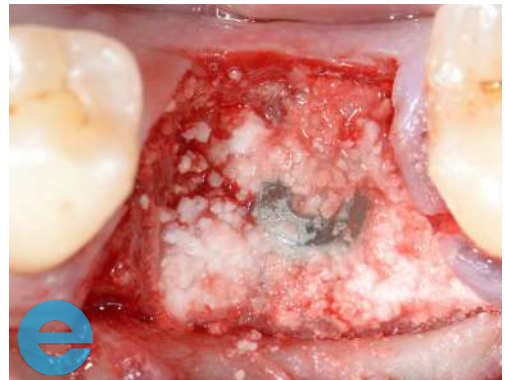
4. Bone grafting with EthOss®.

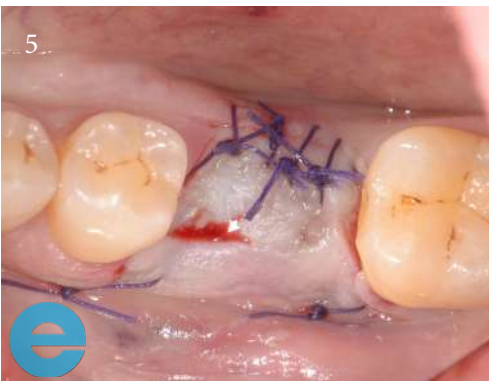
5. Tension free closure.

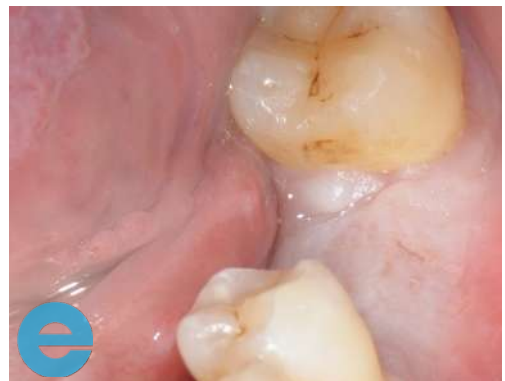
6. Clinical view after 10 weeks.

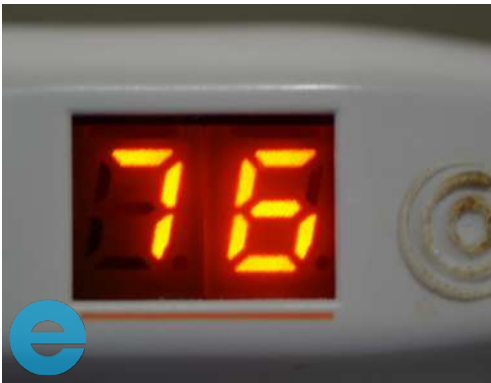
7. ISQ measurement showing high secondary implant stability.

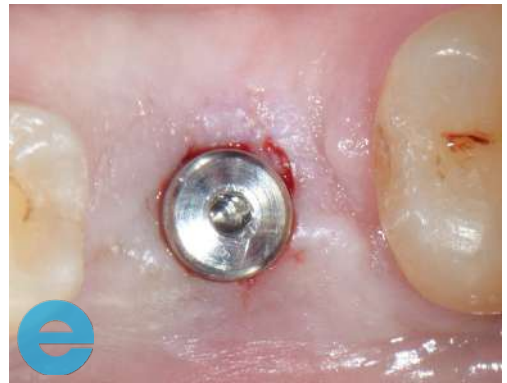
8. Occlusal view after placing of the healing abutment.

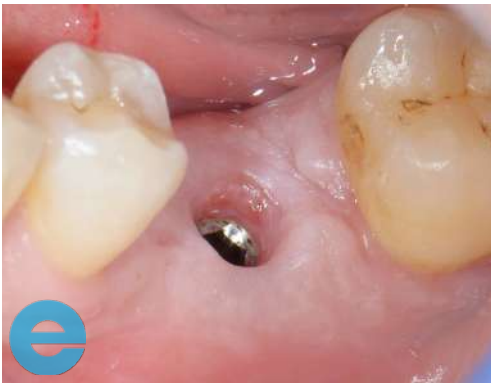
9. Maturation of the soft tissues 2 weeks after placement of the healing abutment.

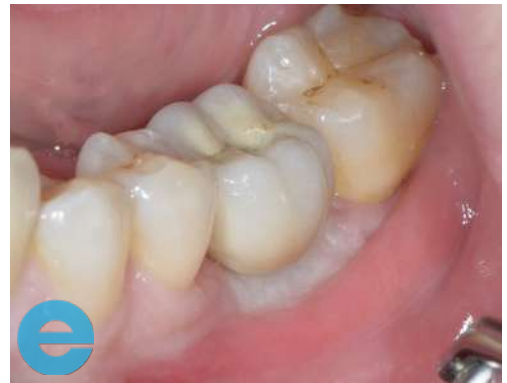
10. Screw-retained metal-ceramic crown fitted and torqued at 35Ncm.

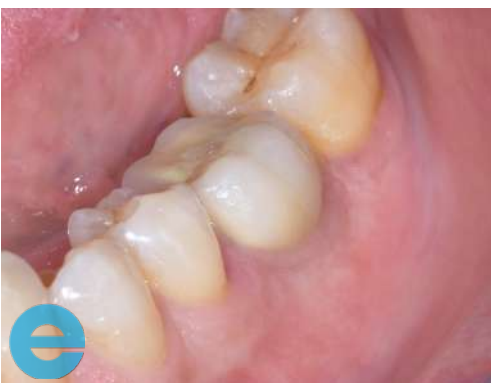
11. Clinical view one year after loading of the implant.

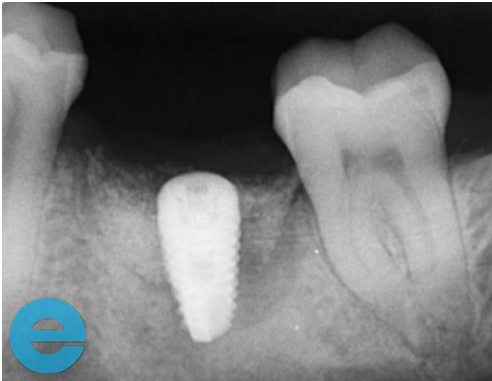
13. Periapical radiograph immediately after implant placement and bone grafting.

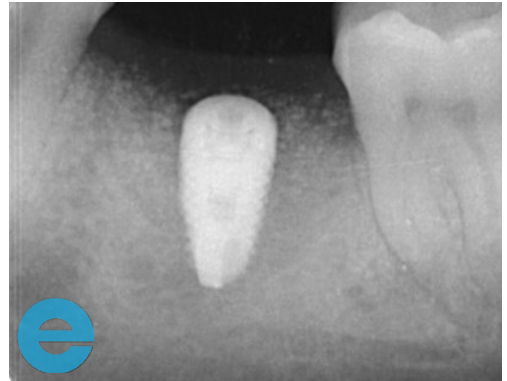
14. X-ray 10 weeks after implant placement and grafting showing the consolidation of the grafting material around the implant.

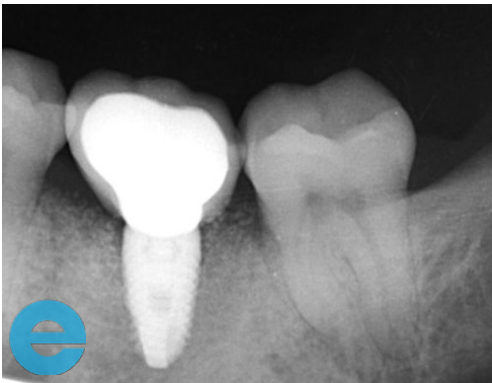
15. X-ray immediately after fitting the implant crown.
